APPENDIX I

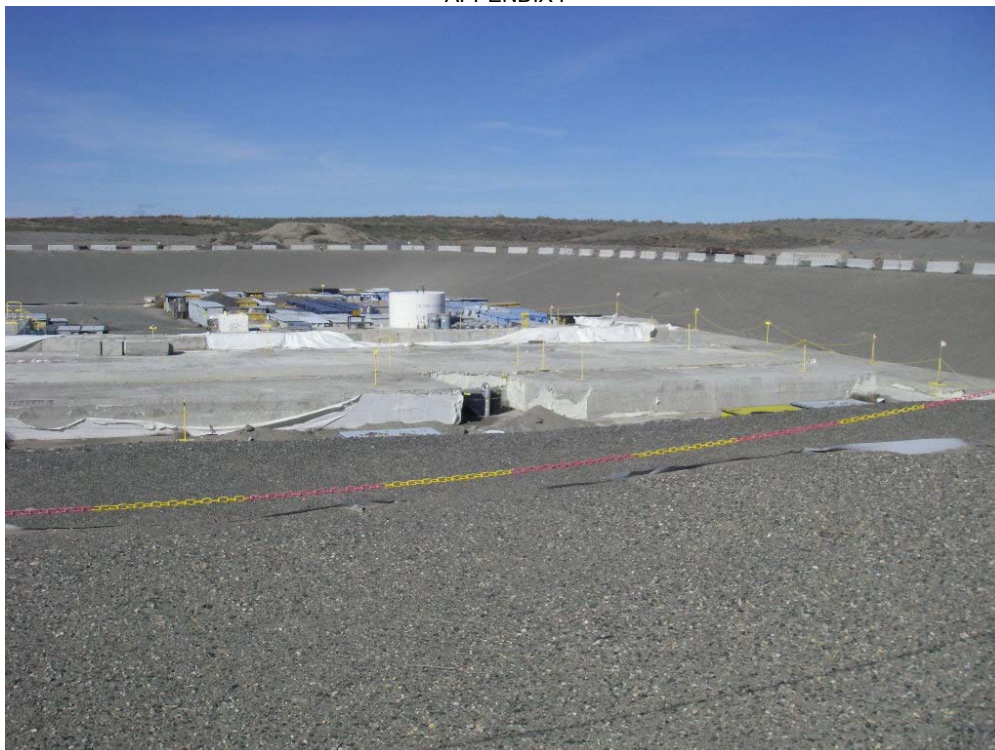
Photo#: IMGP0089 Date/Time: 3/22/2011 10:56:29 AM Photographer: A. Ruhs
Description: Trench 34, showing primary leachate pump-sump (middle of photo). West facing.

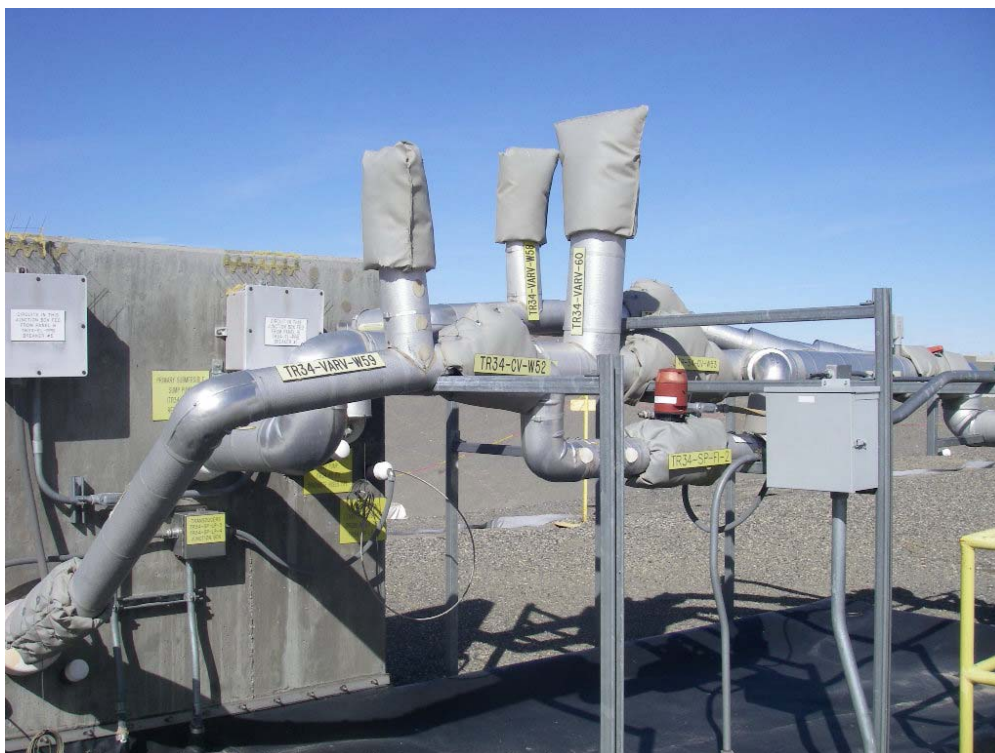
Photo#: IMGP0090 Date/Time: 3/22/2011 11:09:17 AM Photographer: A. Ruhs
Description: Trench 34 secondary and primary leachate-leak detection collection pipes. Far left pipe (foreground) is the leak detection (secondary) collection pipe with a flow meter (red). Ties into the primary (leachate) collection pipe and flows to a combined collection tank. North facing.

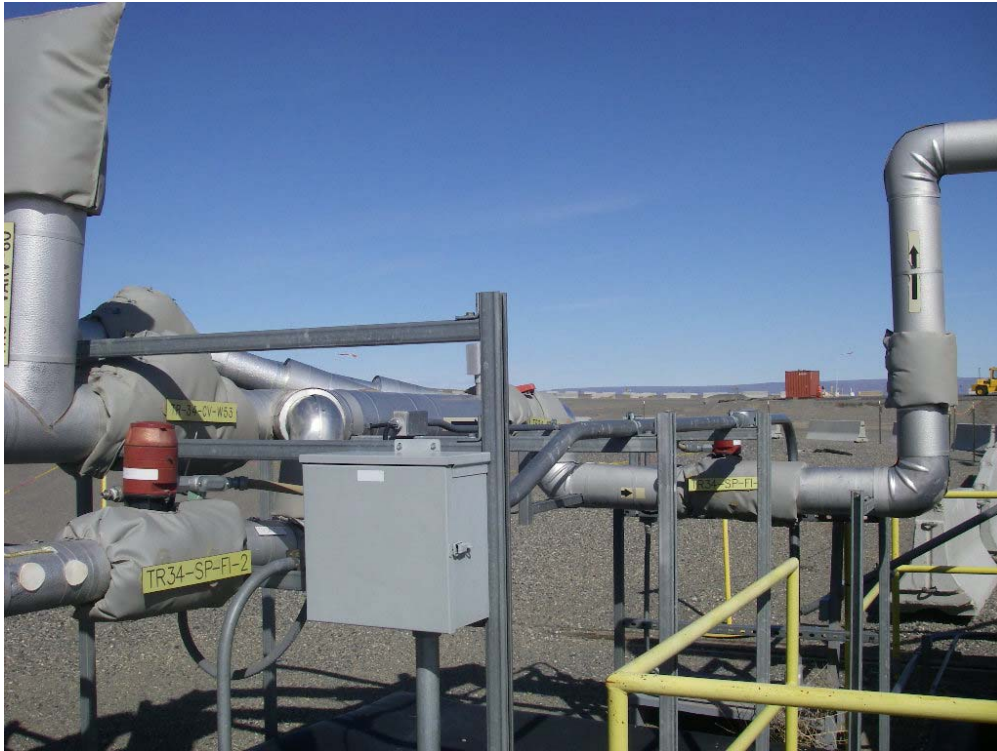
Photo#: IMGP0091 Date/Time: 3/22/2011 11:09:23 AM Photographer: A. Ruhs
Description: Combined pipe from leachate and leak detection collection at trench 34. North facing.

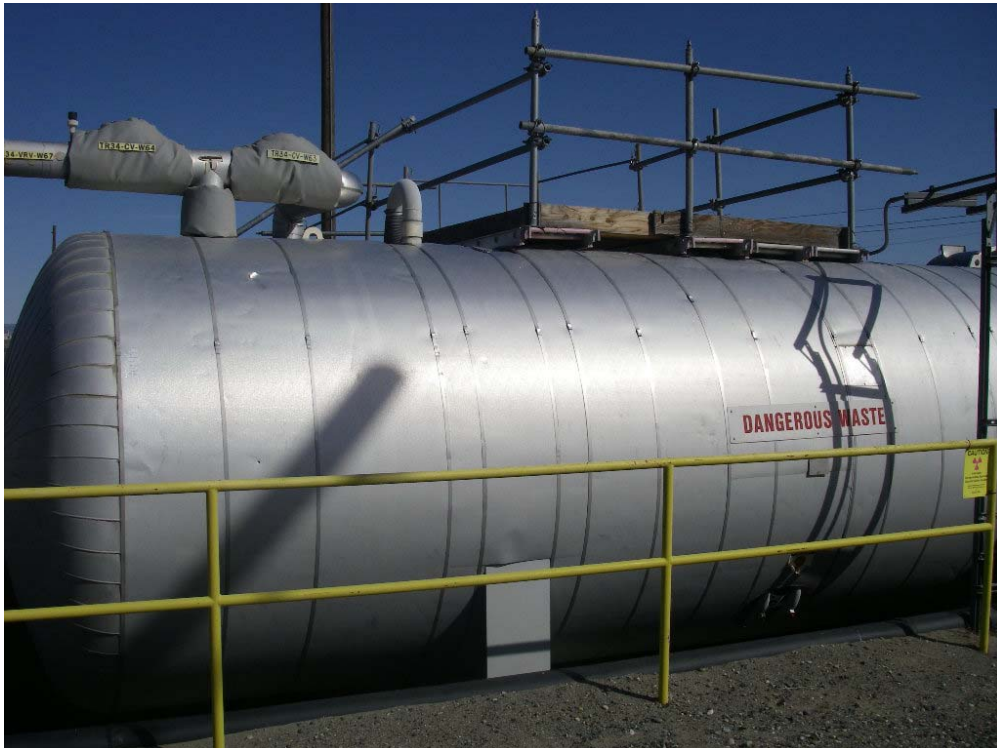
Photo#: IMGP0092 Date/Time: 3/22/2011 11:09:43 AM Photographer: A. Ruhs
Description: Combined leachate-leak detection collection tank (hazardous waste tank) at trench 34. North facing.

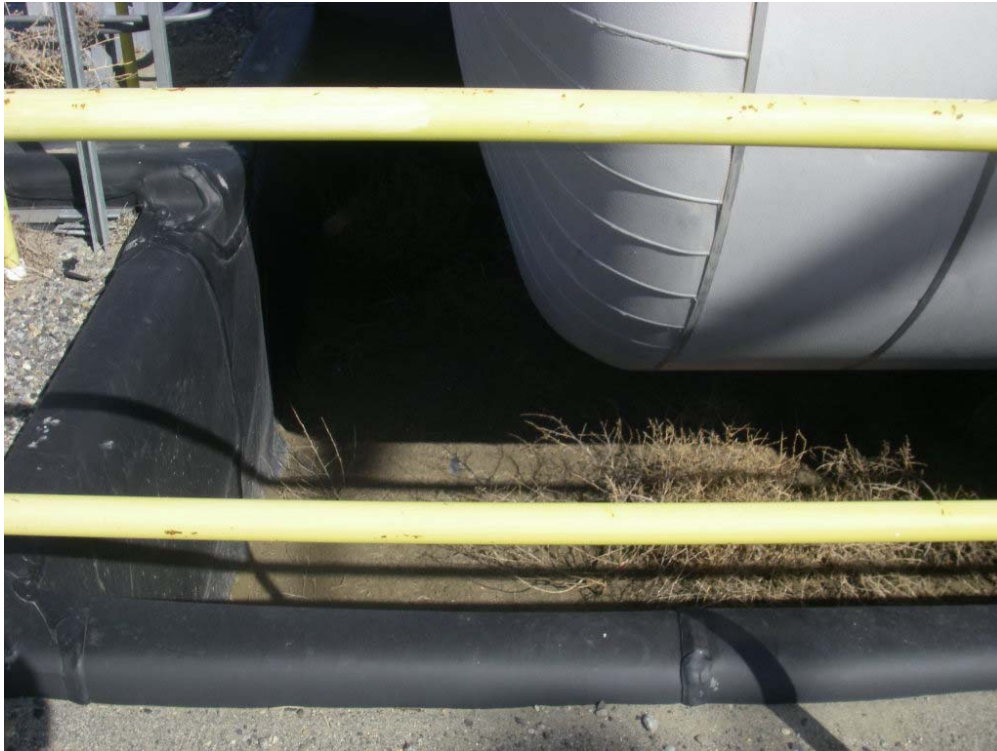
Photo#: IMGP0093 Date/Time: 3/22/2011 11:09:56 AM Photographer: A. Ruhs
Description: View of secondary containment under the leachate collection tank at trench 34. North facing.

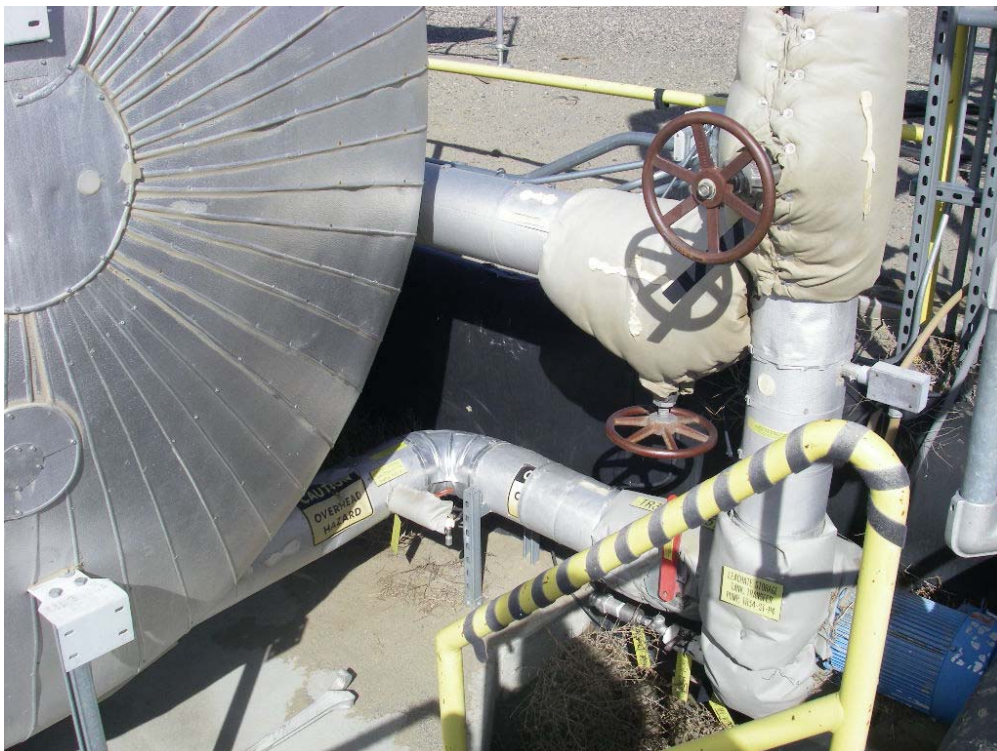
Photo#: IMGP0094 Date/Time: 3/22/2011 11:10:19 AM Photographer: A. Ruhs
Description: Effluent piping from the leachate collection tank at trench 34. Also shows the sample port at bottom of pipe. North facing.

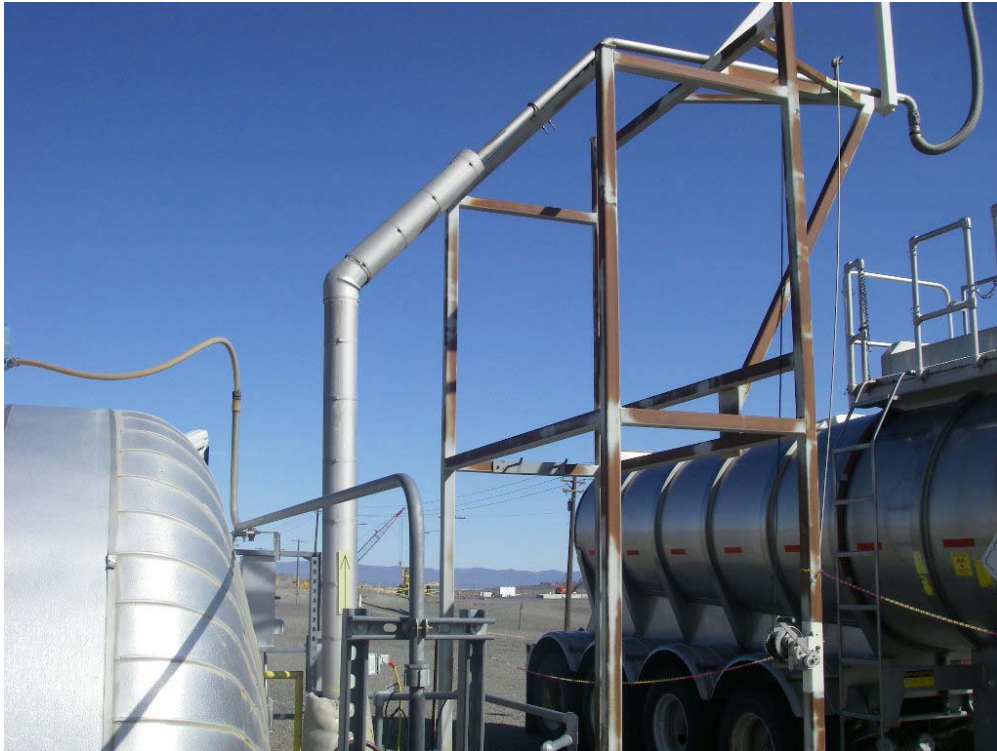
Photo#: IMGP0095 Date/Time: 3/22/2011 11:10:33 AM Photographer: A. Ruhs
Description: Effluent pipe from leachate collection tank at trench 34 going overhead to tanker truck. North facing.

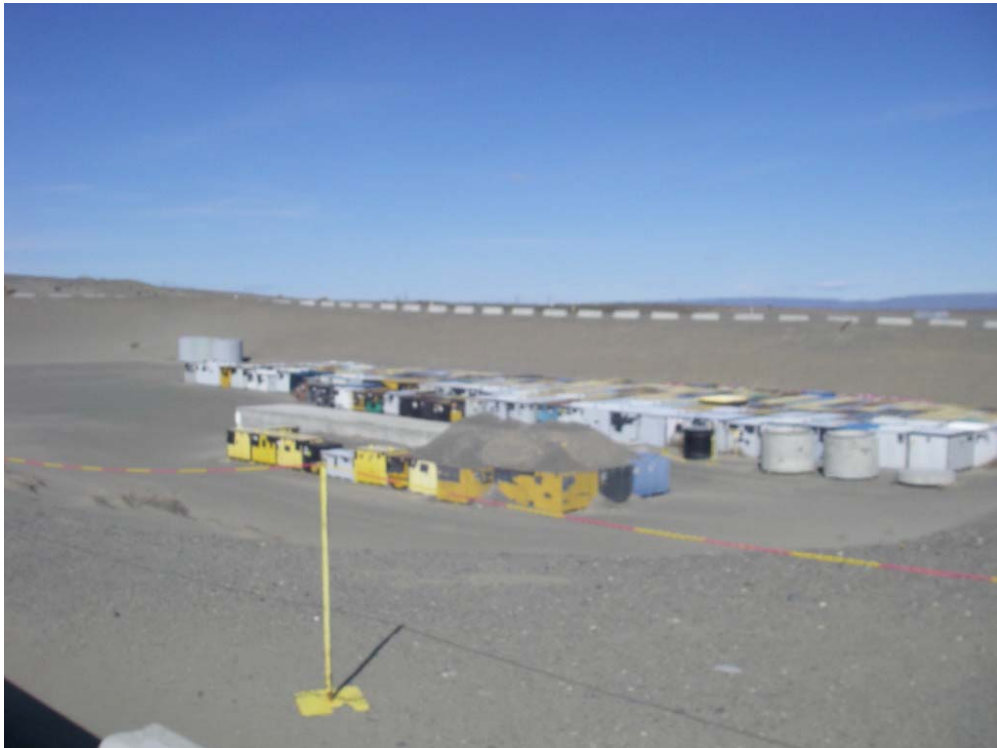
Photo#: IMGP0096 Date/Time: 3/22/2011 11:20:18 AM Photographer: A. Ruhs
Description: Overview of Trench 31. West to northwest facing.

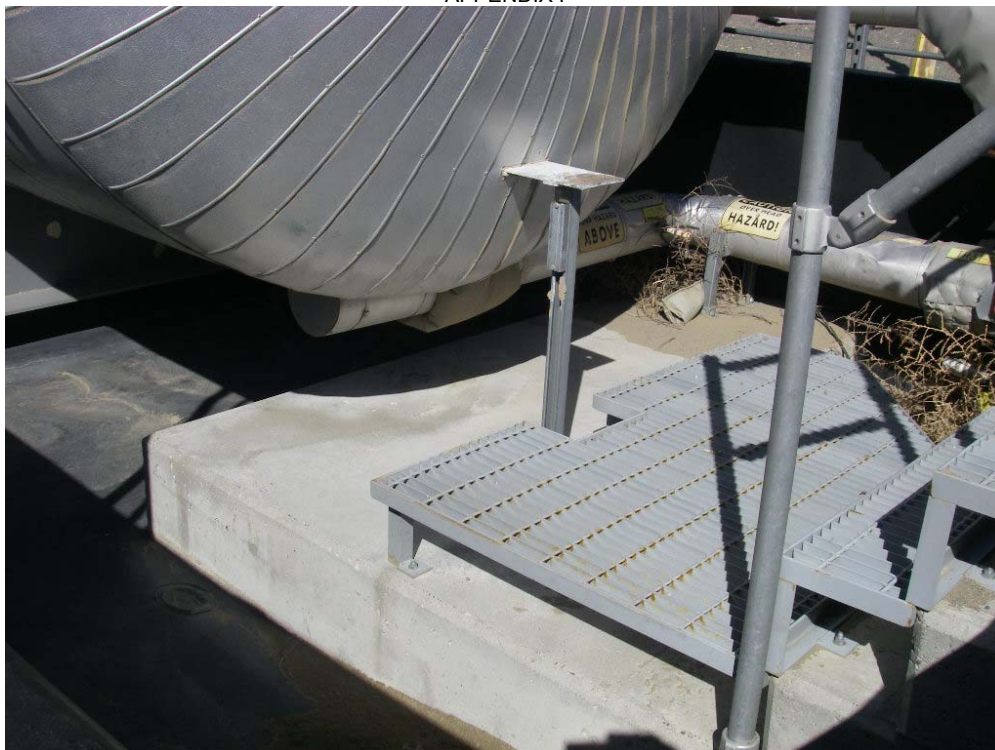
Photo#: IMGP0097 Date/Time: 3/22/2011 11:26:39 AM Photographer: A. Ruhs
Description: Close-up of secondary containment of the leachate collection tank at trench 31. North facing.
